# *Indian Ocean Earthquake- Tsunami of 26 December 2004*

## **UNDAC Rapid Environmental Assessment Republic of Maldives**

January 2005

## **Joint UNEP/OCHA Environment Unit**

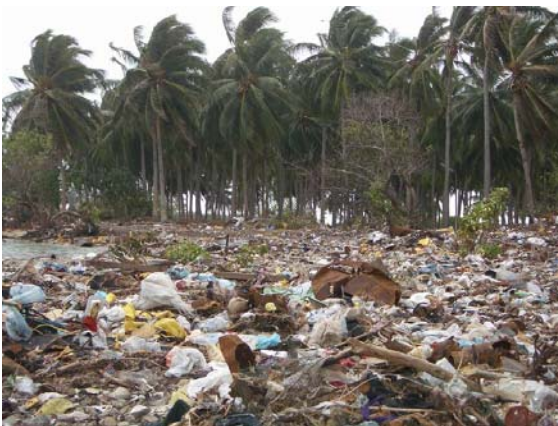
The tsunami destroyed an enormous amount of houses on numerous islands. At the time of writing the Government of the Maldives had registered 3997 houses that had been damaged. The amount of construction/demolition waste consists from individual cement bricks to complete intact walls that have collapsed. On some of the worst affected islands, such as Vilifushi on Thaa Atoll, all the houses have been completely destroyed.

***The tsunami has exacerbated already poor waste management practices***

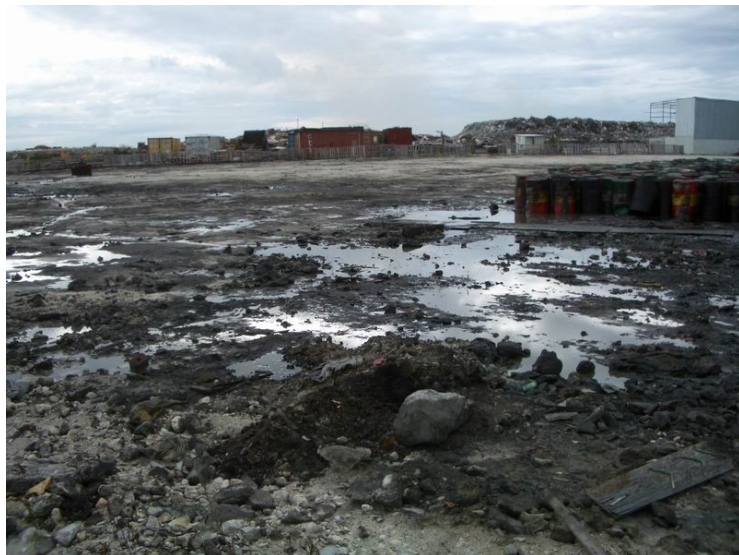
Thilafushi is an island close to Male and consists of three main parts; storage houses, light industries and the main waste dump site of the Maldives. On the part of the island where the waste is being dumped approximately 300 drums of 205 liters containing used oils are being stored next to the water. No containment walls or foundation against leakage are in place.

***Poor storage facility and waste oil spill threaten the marine environment***

The waste oil is collected and used as fuel to burn the waste that is being dumped and burnt in open air. The drums are in very poor condition: rusted and some of them are open. An area of approximately 200 m<sup>2</sup> has been polluted with a layer of waste oil. At the moment of the site visit, oil was still flowing into the

sea. To the responsible staff present, the urgent recommendation was made to immediately build a small dam to prevent further seawater contamination. A further clean up and proper treatment of the polluted soil is required.
