## **ASGM GLOBAL FORUM IN PHILIPPINES FROM 7<sup>th</sup> – 9<sup>th</sup> DEC, 2010**

### **PRESENTATION FROM MR. GOLDEN N. HAINGA - GENERAL SECRETARY OF THE MWANZA REGION MINERS ASSOCIATION - TANZANIA**

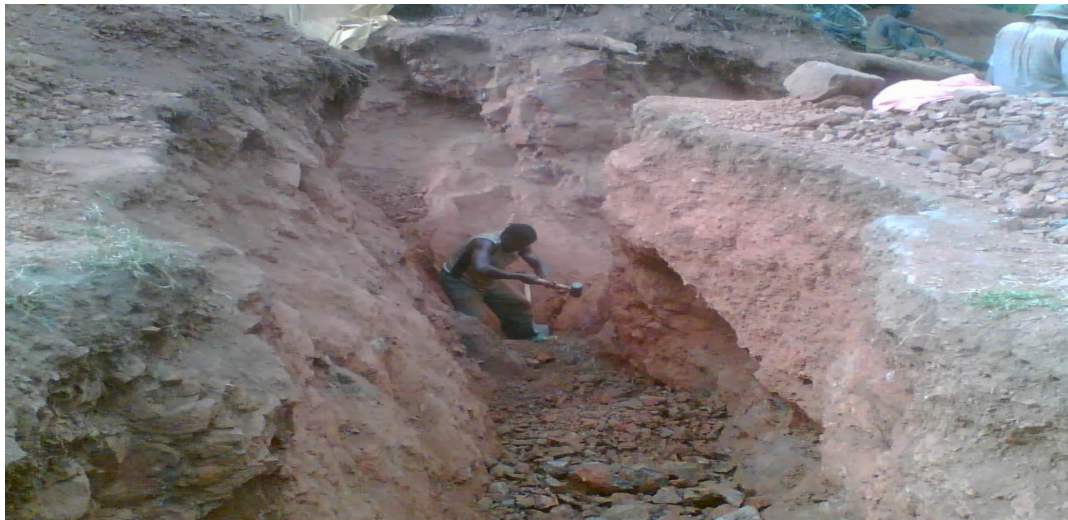
Figure: 1 Illustrate mining using rudimentary tools

Small scale mining in Tanzania can be characterized as mining operations which are labour intensive for operators with informal technical knowledge of mining and mineral processing and little capital. They can embark on mining with crude tools like picks, shovels and pans (See Figure 1&2). In the operations, miners are coupled with wastage of

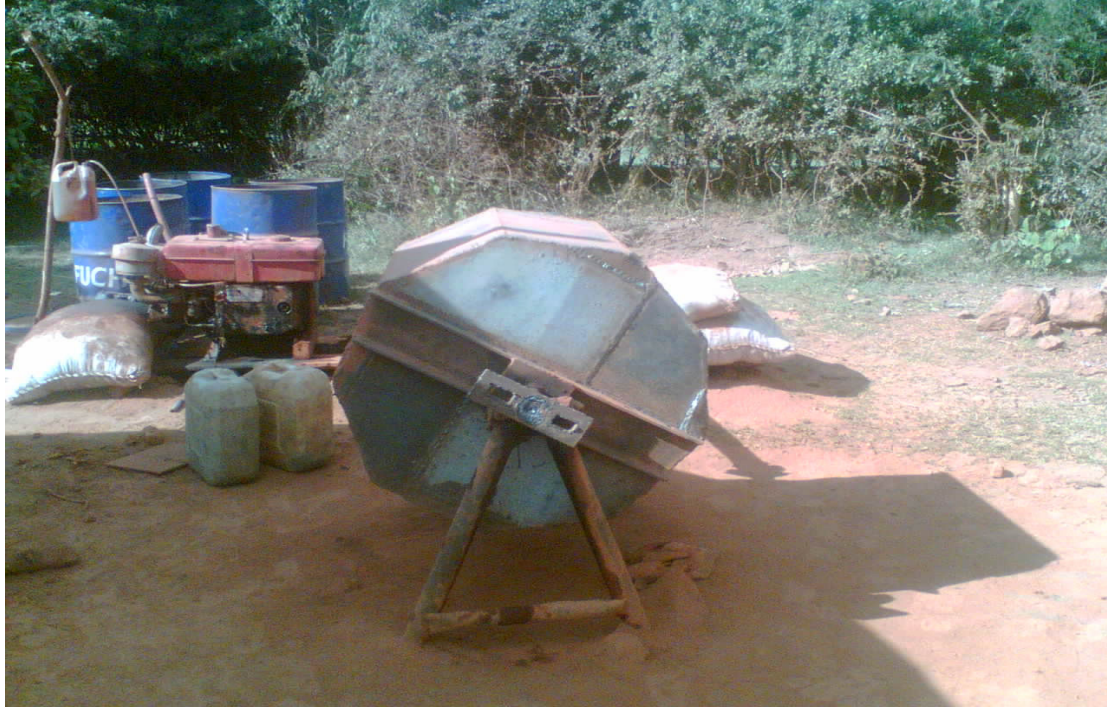
Figure 2: Local ball mill for grinding the mined ore

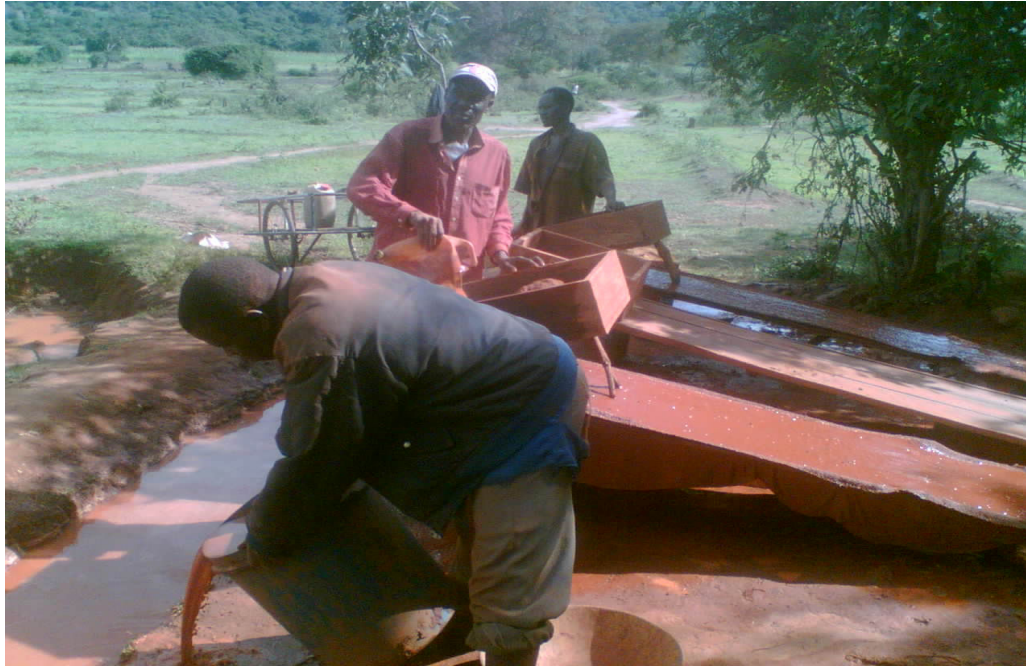
Figure 3: Gold extracted using local table

The ore is crushed by hand hammers into small sizes which are then dried and grinded by ball mills into fine powdered raw material. The obtained fine powder from mill is then put into sluice boxes where water is carefully added using buckets or water pipes (See figure 3). A constant water flow is maintained to high recovery of gold from the ore. The sluice boxes are covered by carpets to capture fine gold as it runs down the sluice boxes. The finer the gold grains are, the less efficient is the sluicing process. After sluicing process, the

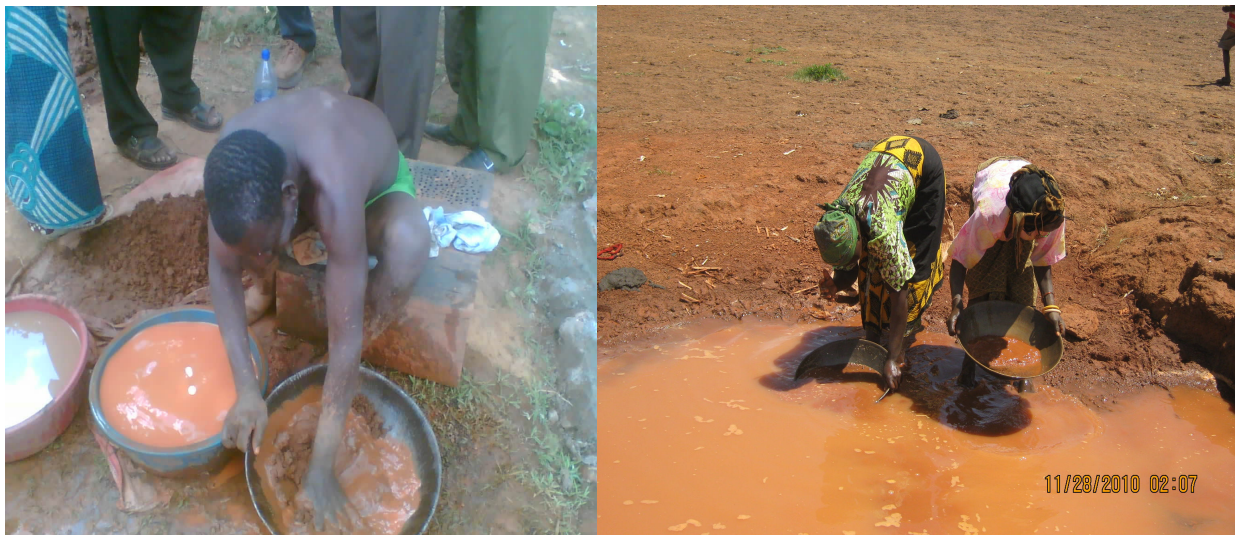
Figure 4: Illustrate ore amalgamation with mercury

carpets are washed in large metallic or plastic trays or containers. The obtained mineral ore concentrate will be amalgamated by using mercury (See figure 4).
